Subject: Report of Current Activities

## HYCON MODEL 73-C CAMERA SYSTEM

## CONFIGURATION B, REWORK

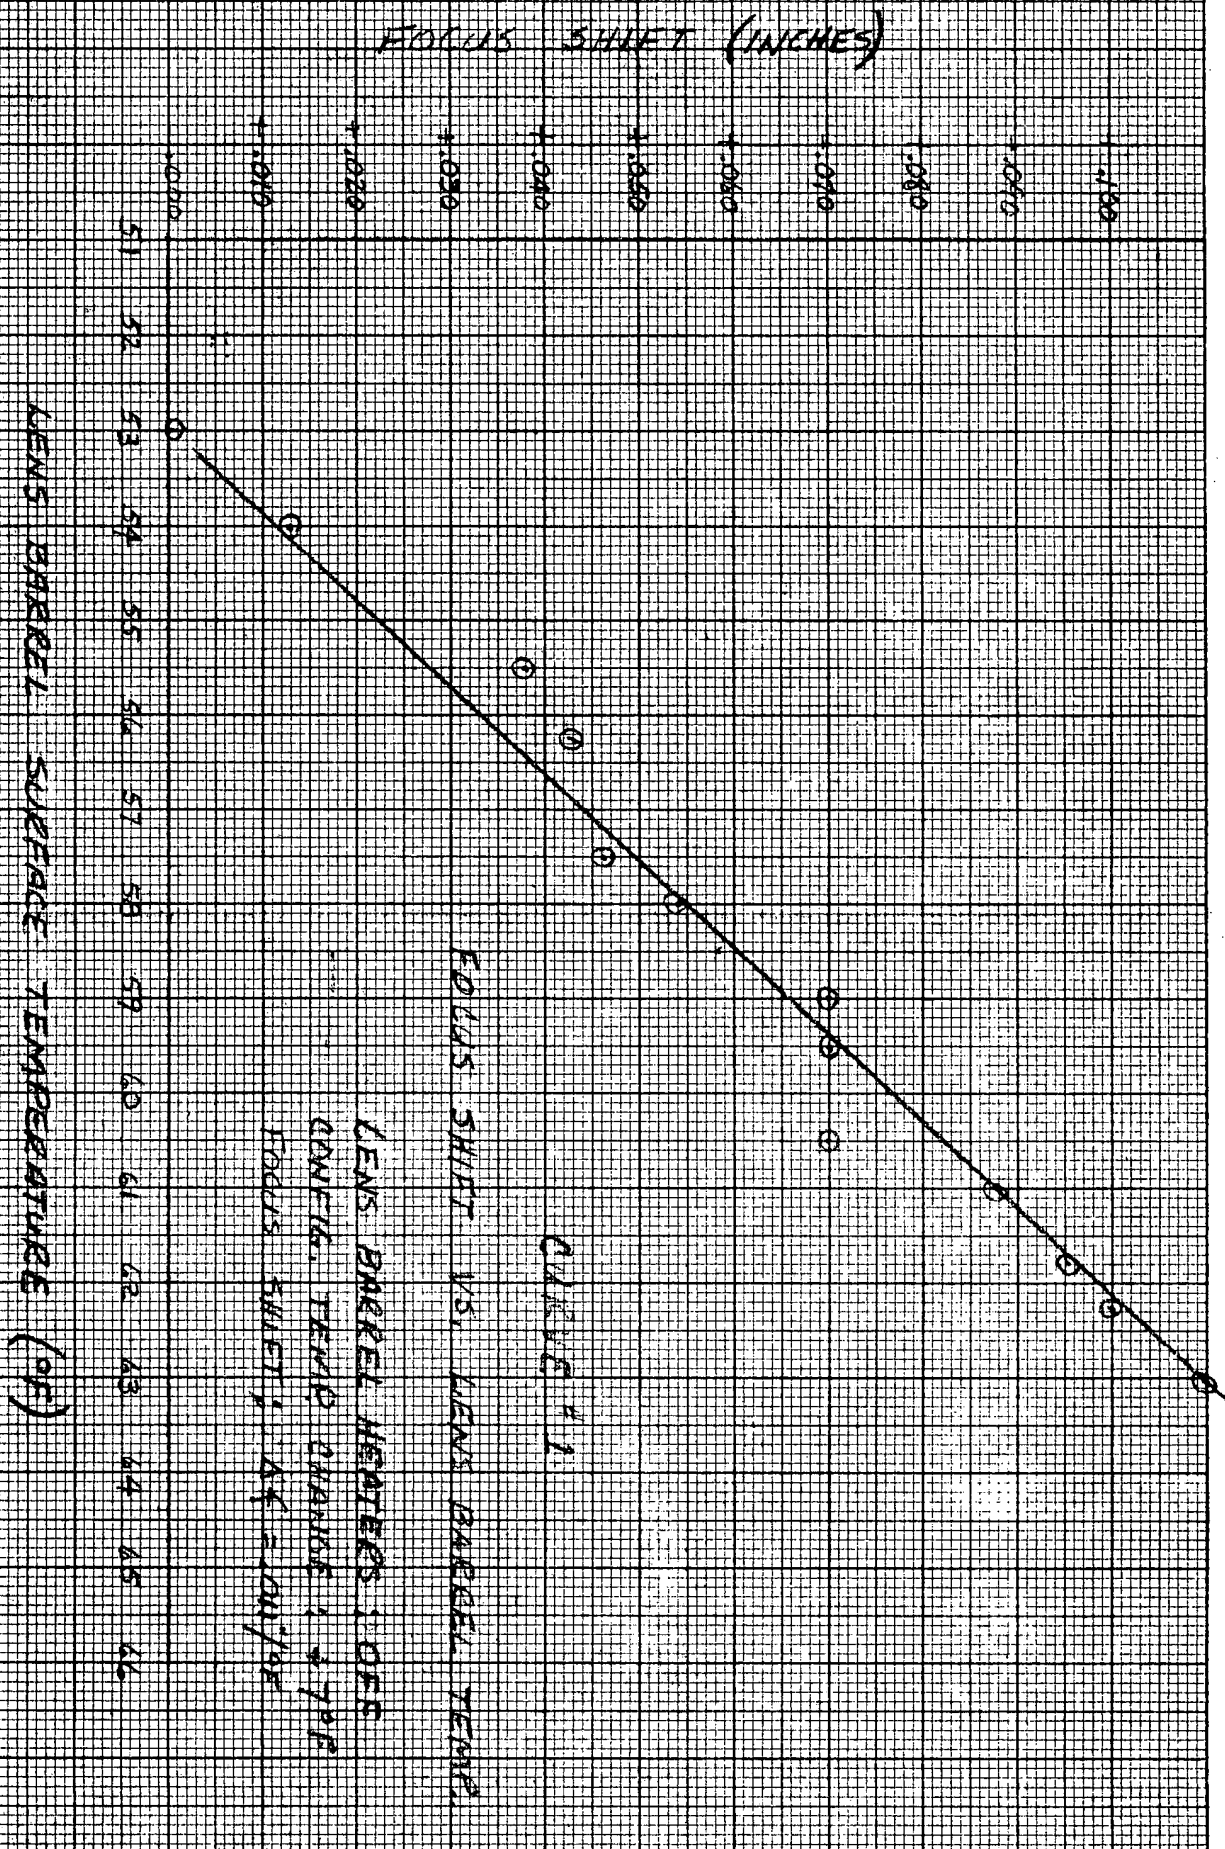
CURVE NO. 1

In the temperature range of 53° F to 84° F, average focus shift was found to be .011 inches per degree F (Curves #1 and #2). The direction was such that a decrease in temperature resulted in a decrease in back focal length, and vice-versa.

Curve #1 and Curve #2 are curves of lens barrel surface temperature vs focus shift for two different temperature ranges. It is interesting to note that on Curve #1 the overall configuration temperature rose  $7^{\circ}\text{F}$  while the lens barrel surface temperature rose  $10^{\circ}\text{F}$ , and the incremental focus shift, was  $\Delta f = .011"/^{\circ}\text{F}$ . (Focus shift is indicated as a positive number, that is BFL increased with increasing temperature.) In curve #2, the configuration temperature remained constant while the lens barrel surface temperature was caused to rise  $17^{\circ}\text{F}$ . In this case, the incremental focus shift was  $\Delta f = .014"/^{\circ}\text{F}$ . Curve #2, then, is probably a fairly accurate representation of the effect of temperature change on the optical elements in the projection lens barrel only. Curve #1 in which the configuration temperature varied slightly, still yields results which are reasonably consistent with those of Curve #2.

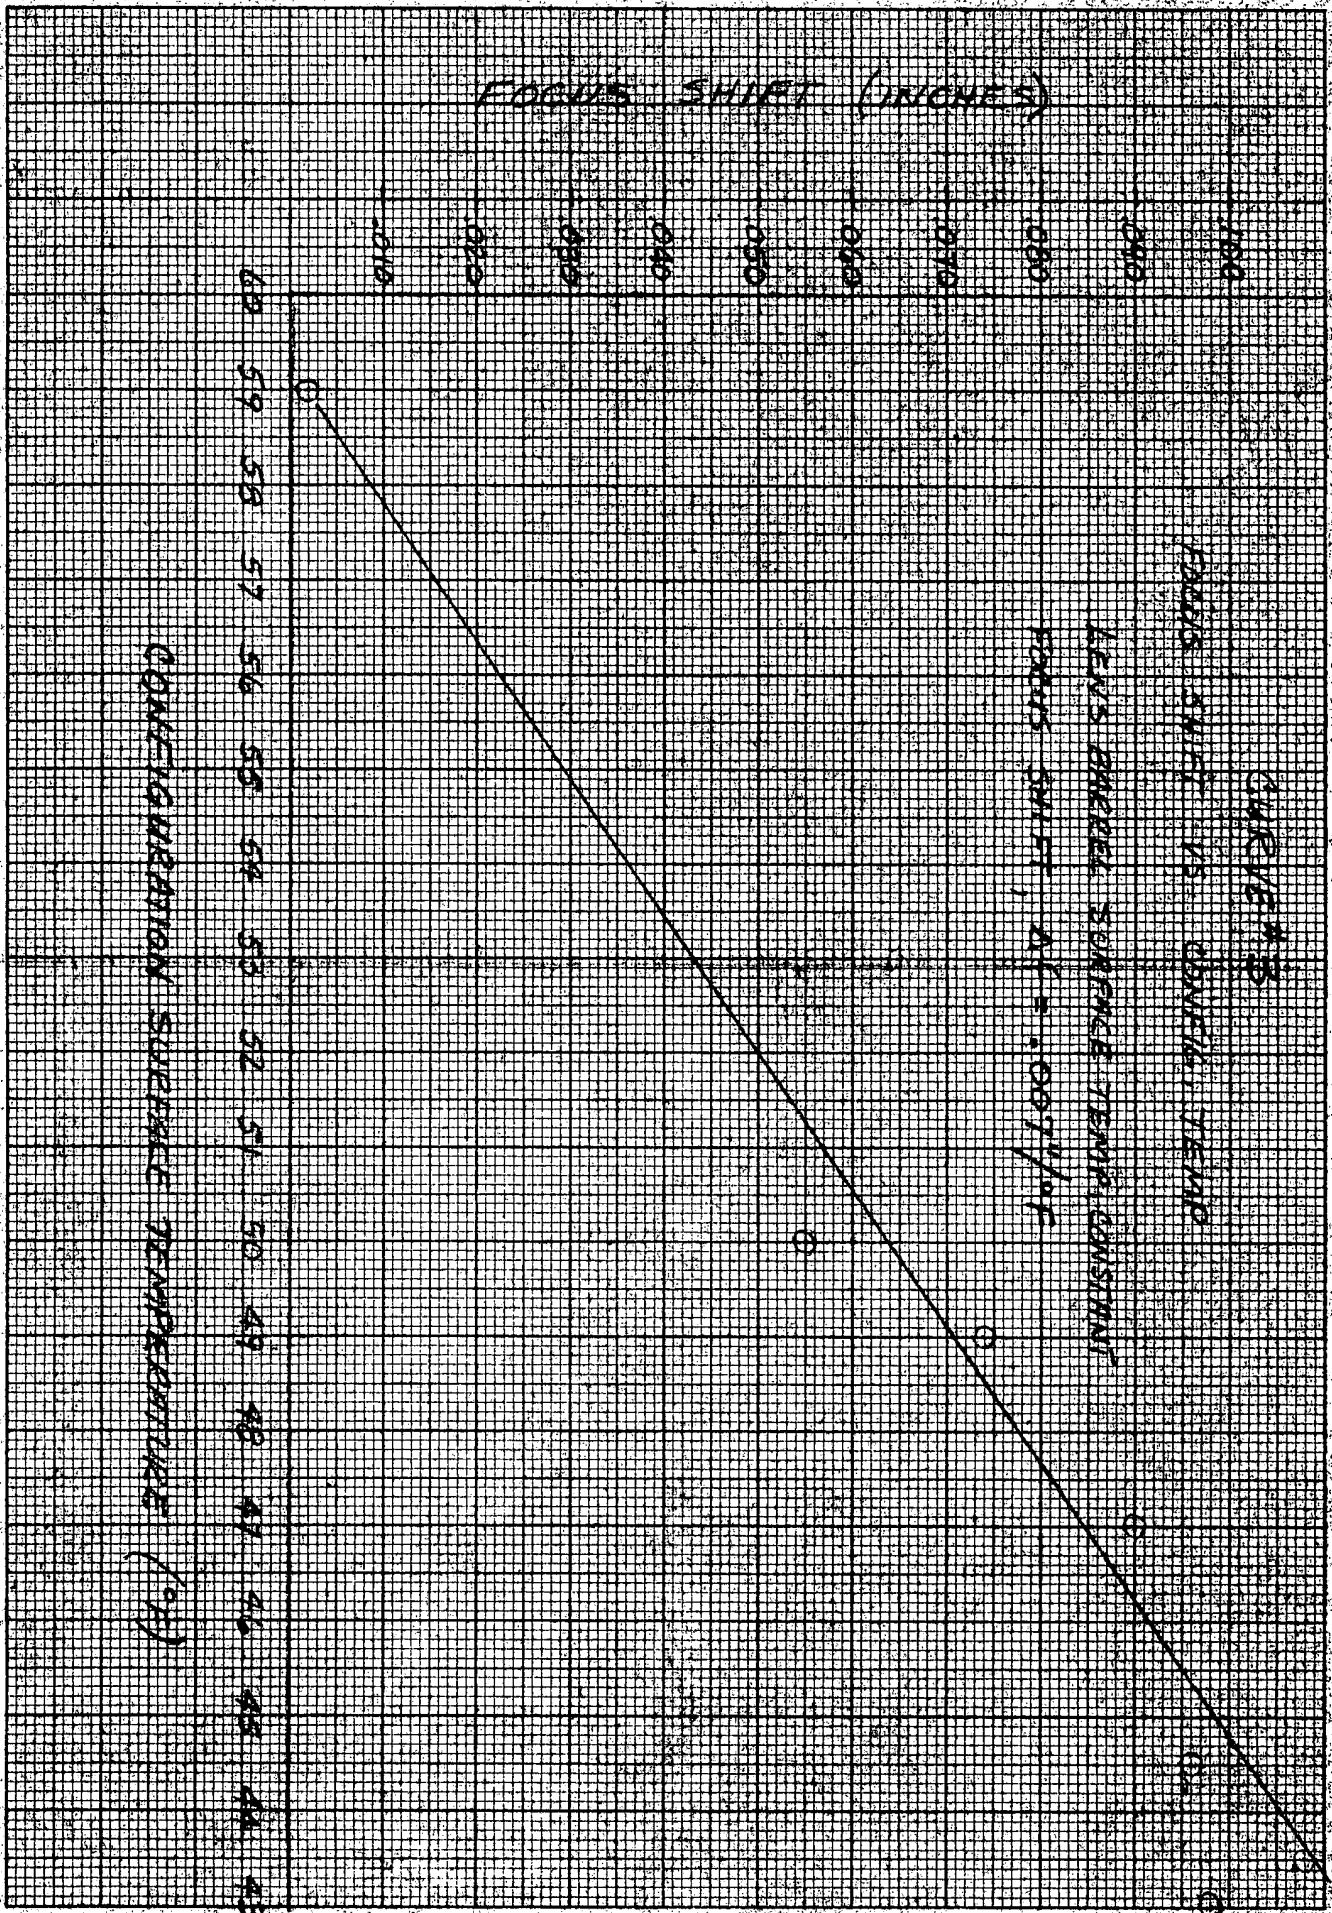
CURVE NO. 3

Because of the turbulence existing when the configuration was being cooled, it was difficult to accurately read focus shift during the test that duplicated in-flight temperature conditions. However, the results are summarized in Curve #3 where the incremental focus shift was found to be .007 inches per degree F.

The test summarized in Curve #3, gives an indication of the effect on focus caused by a temperature change in the configuration. The lens barrel surface temperature was held constant by means of the barrel heaters. Because of the turbulence present, during cooling, the results of this test are not very accurate, but, do indicate that the direction of focus shift is in the same direction as curves #1 and #2. Although, in this test, the lens barrel, barrel surface temperature was kept constant, the lens barrel heaters were on most of the time. This would indicate that there is probably considerable heat loss in the lens barrel, and that the lens barrel heaters may not be adequate, and that the lens barrel is actually contributing to some of the focus shift indicated in Curve #3. This is another feature that will be checked during the next series of temperature tests.
